HgCdTe Detector Reliability Study for the GOES Program

**David G. Seiler
George G. Harman
Jeremiah R. Lowney
Santos Mayo
Walter S. Liggett, Jr.**

**U.S. DEPARTMENT OF COMMERCE
National Institute of Standards
and Technology
Gaithersburg, MD 20899**

September 1991

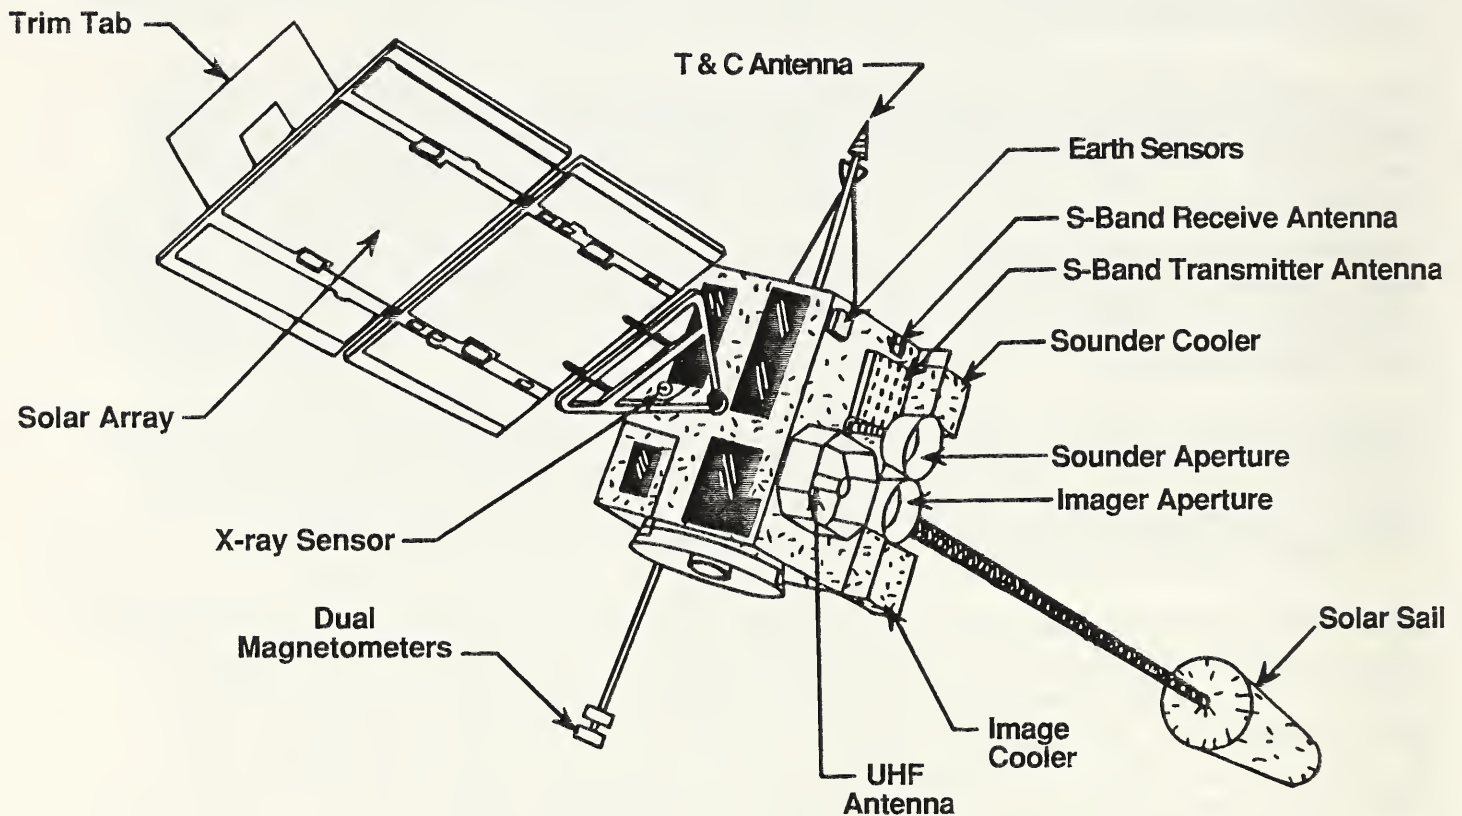
Figure 1.1 Schematic view of a GOES satellite [1.1].

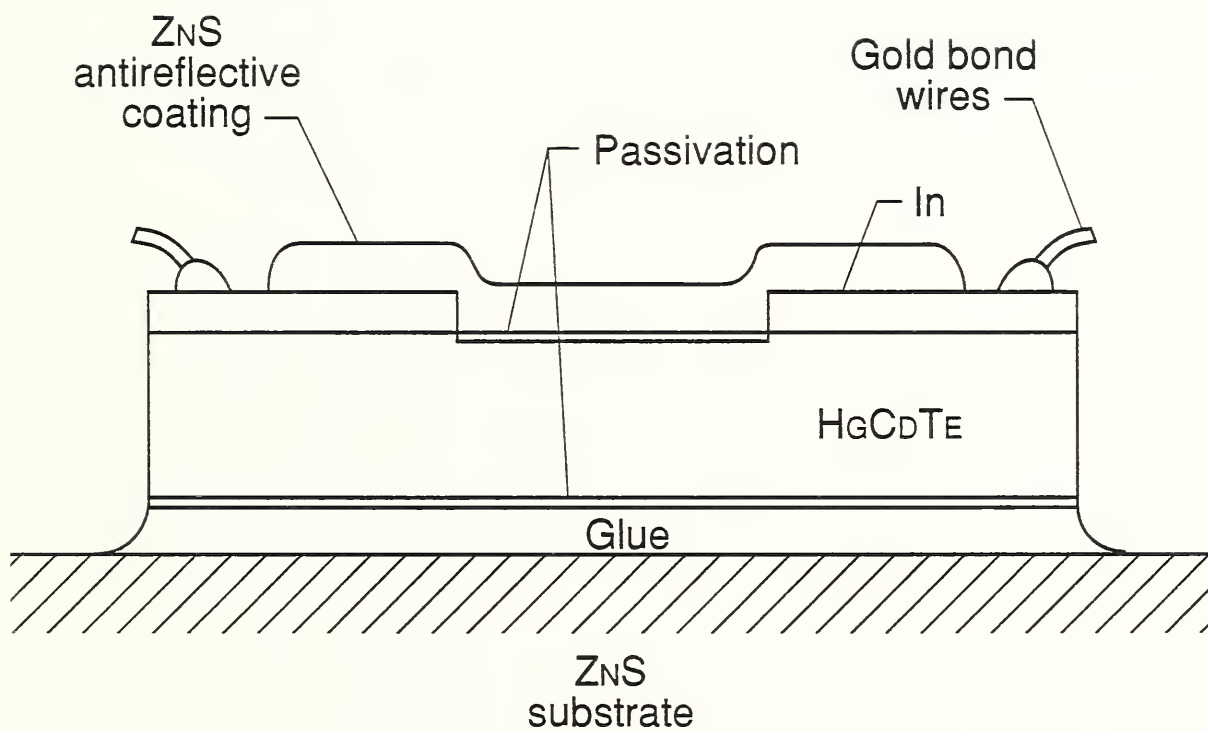
Figure 2.1 Principal components of a HgCdTe GOES detector element [2.1]. The 7- μm -wavelength detectors have two elements; the 11- μm - and 12- μm -wavelength detectors, four.

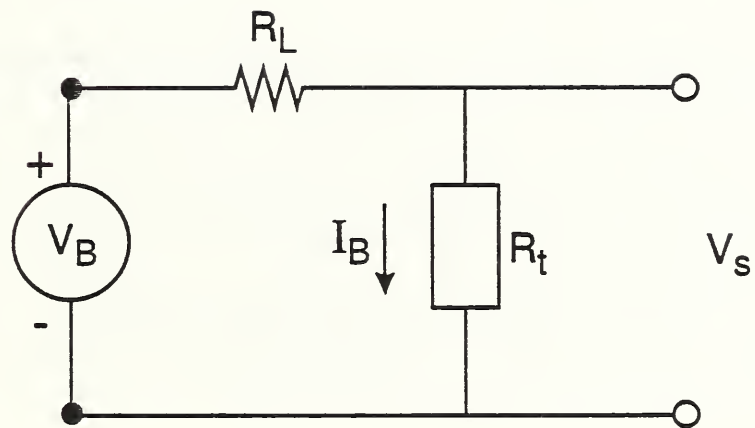
Figure 3.1 Equivalent measurement circuit for detectors. V_B is the bias voltage; I_B , the bias current; R_L , the load resistance; R_t , the total detector resistance, and V_s , the signal voltage.

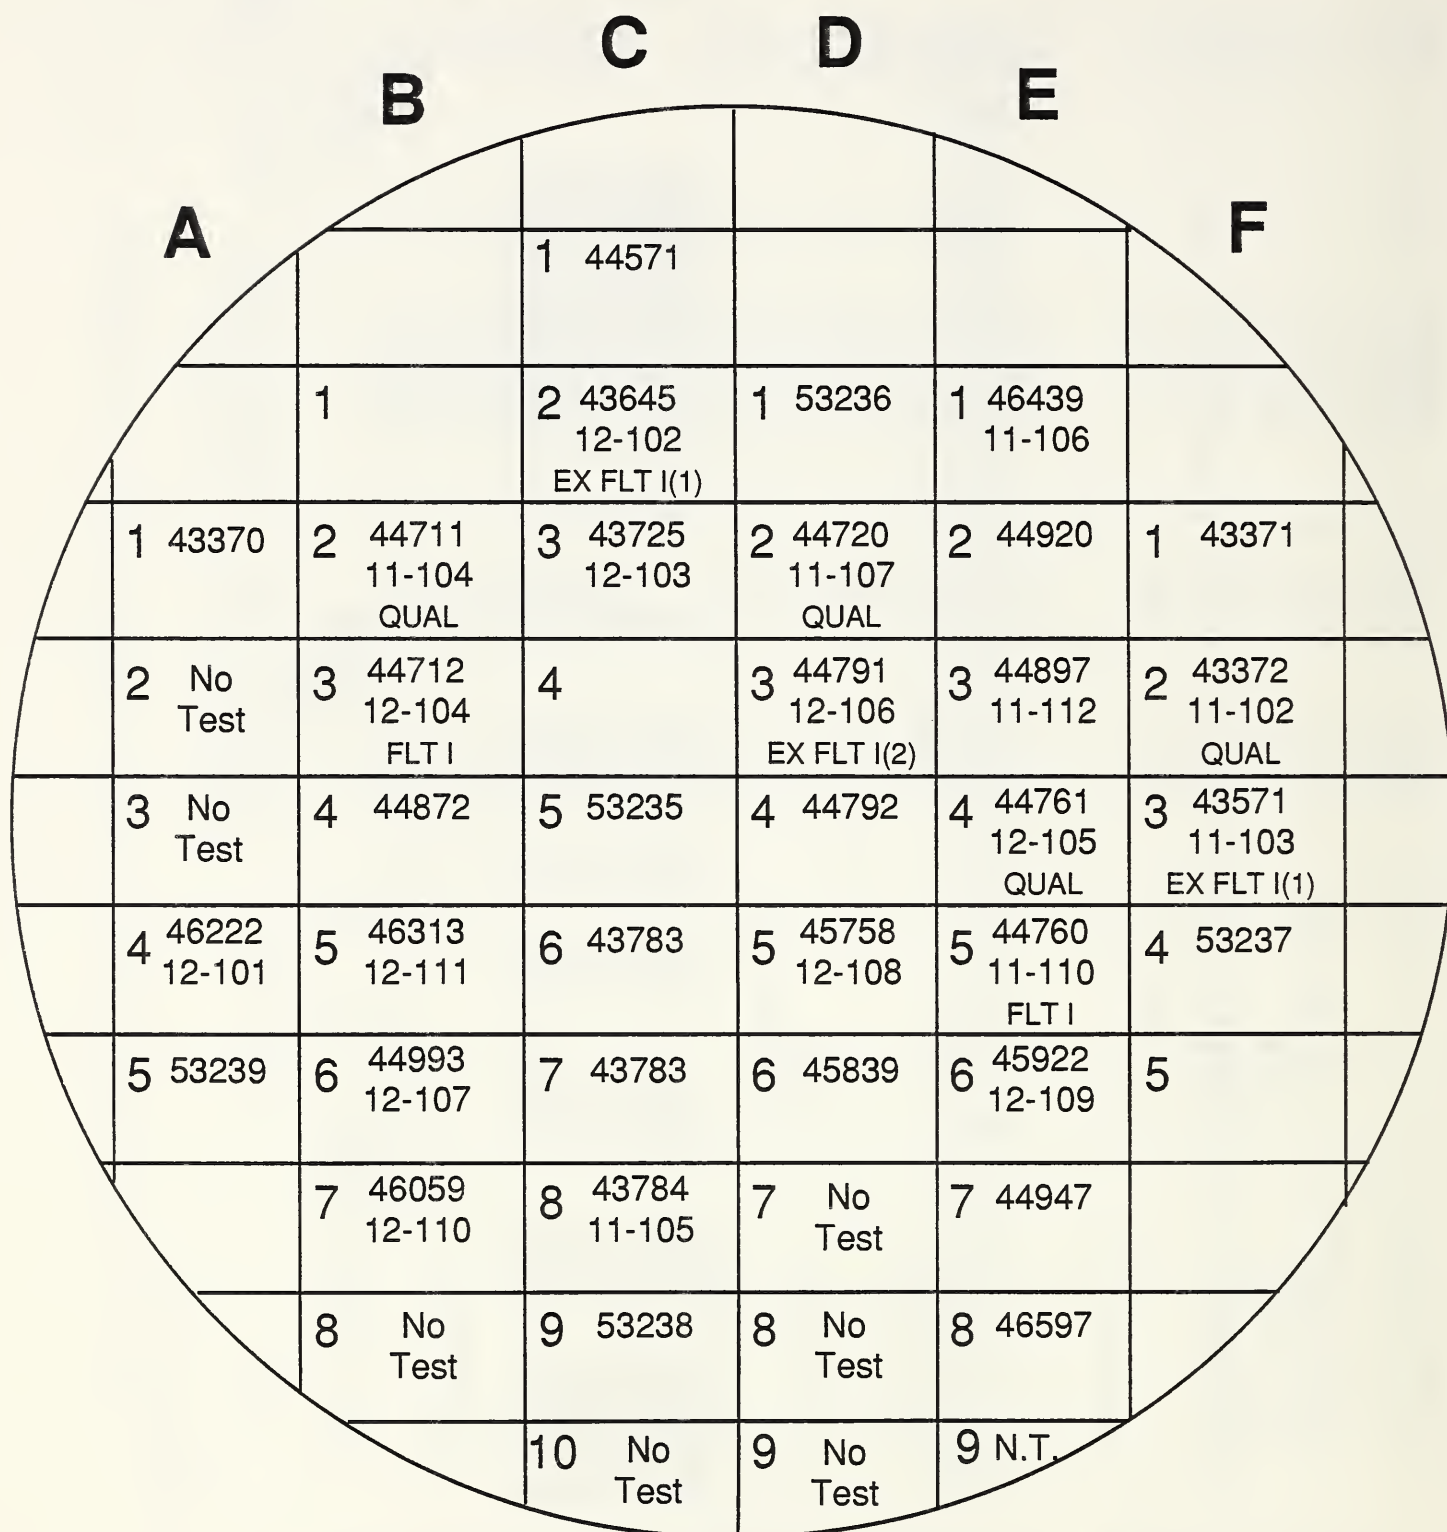
HgCdTe DETECTOR Wafer Map (P3948-33)

Figure 4.1 Wafer map of the 11- and 12- μ m detectors showing the placement of the various detectors.

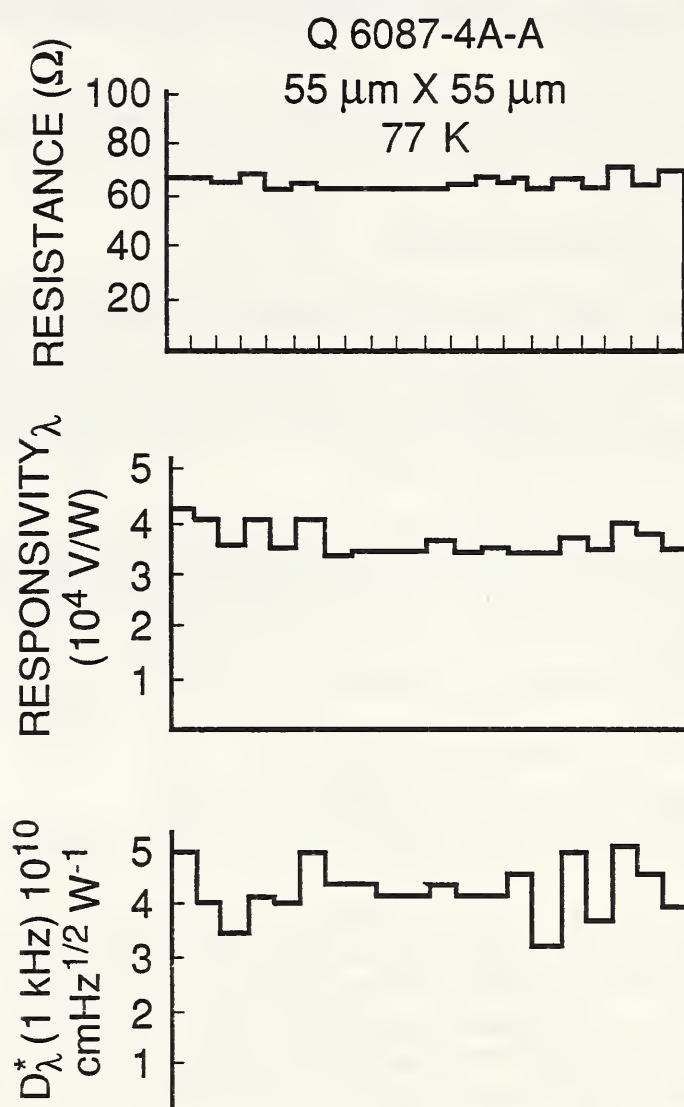
Array Uniformity

Figure 4.2 Degree of uniformity, at 77 K, typically achievable in a 20-element array of 55- μm by 55- μm active area detectors for an ambient background flux [4.2].

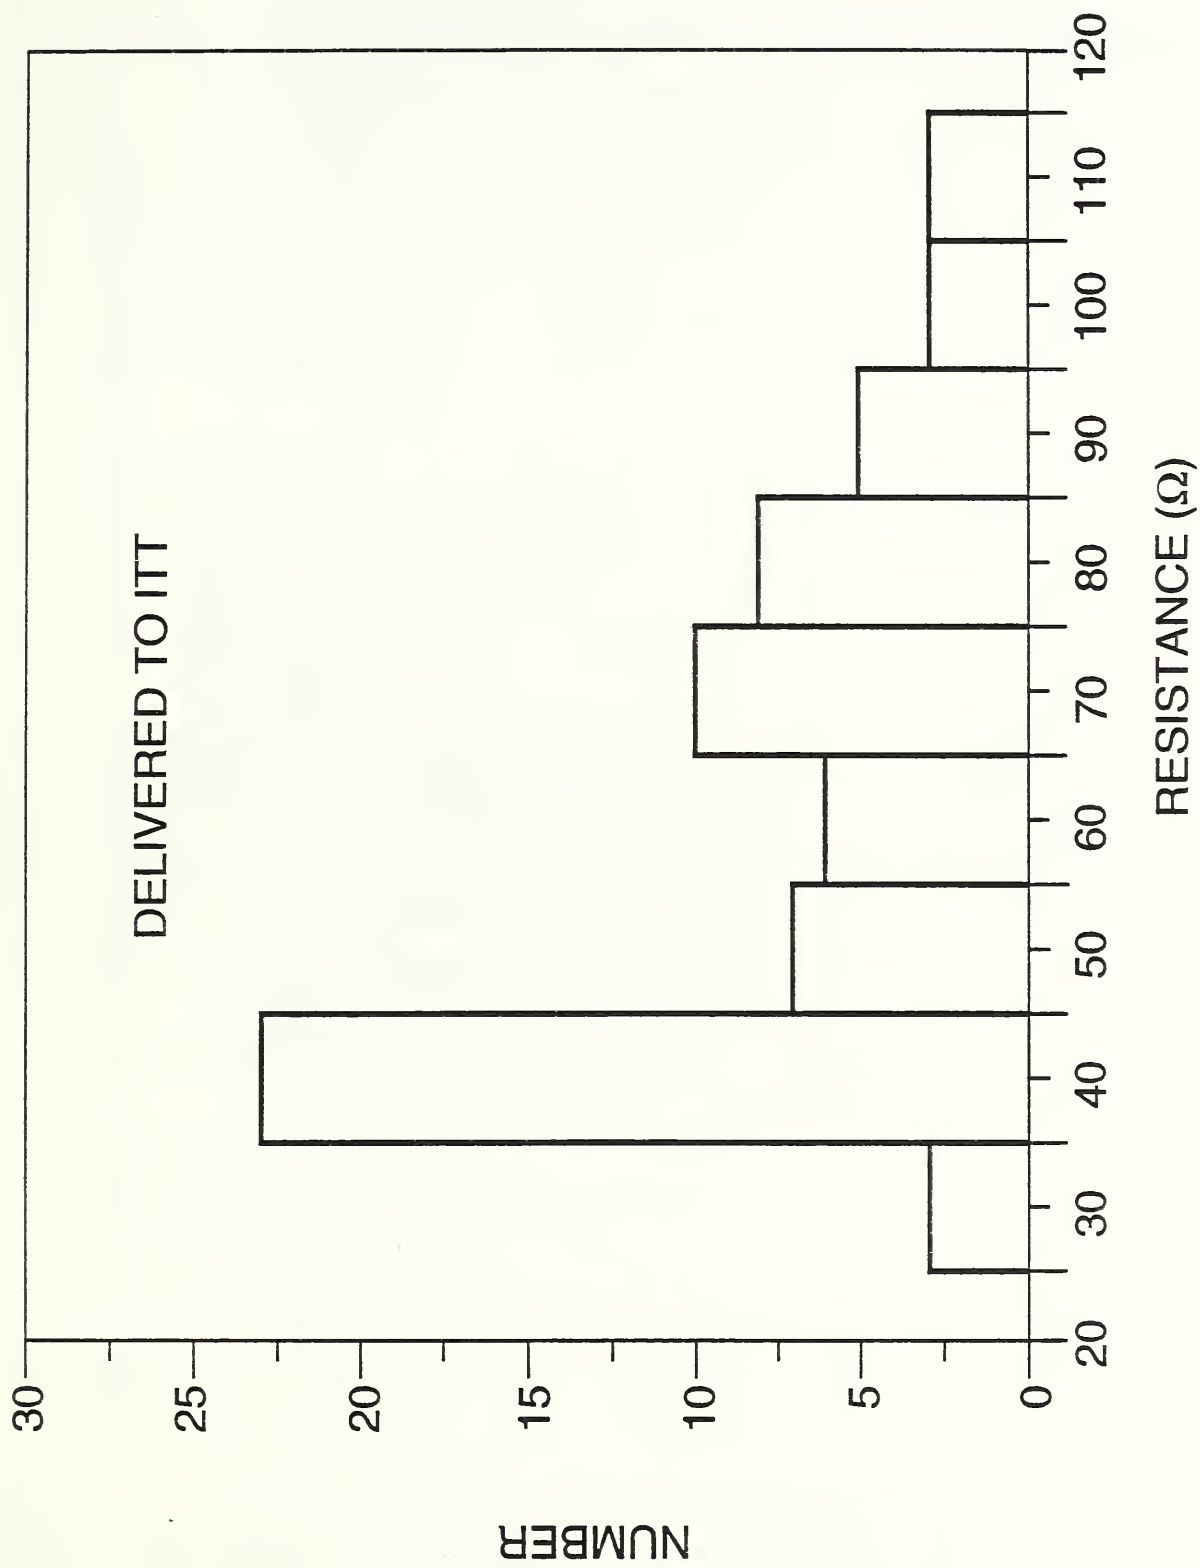
The histograms of the resistances of the 11- and 12- μm detectors shown in figures 5.1 and 5.2 show that many detectors have values that are much larger than the theoretical values. Because the theoretical values correspond well with the lowest measured values, it is assumed that these detectors have low contact resistance. A high contact resistance is significant because it can contribute to excess noise and optically active contact areas.

Figure 5.1 Histogram of the resistances of the 11- and 12- μ m detectors delivered to ITT.

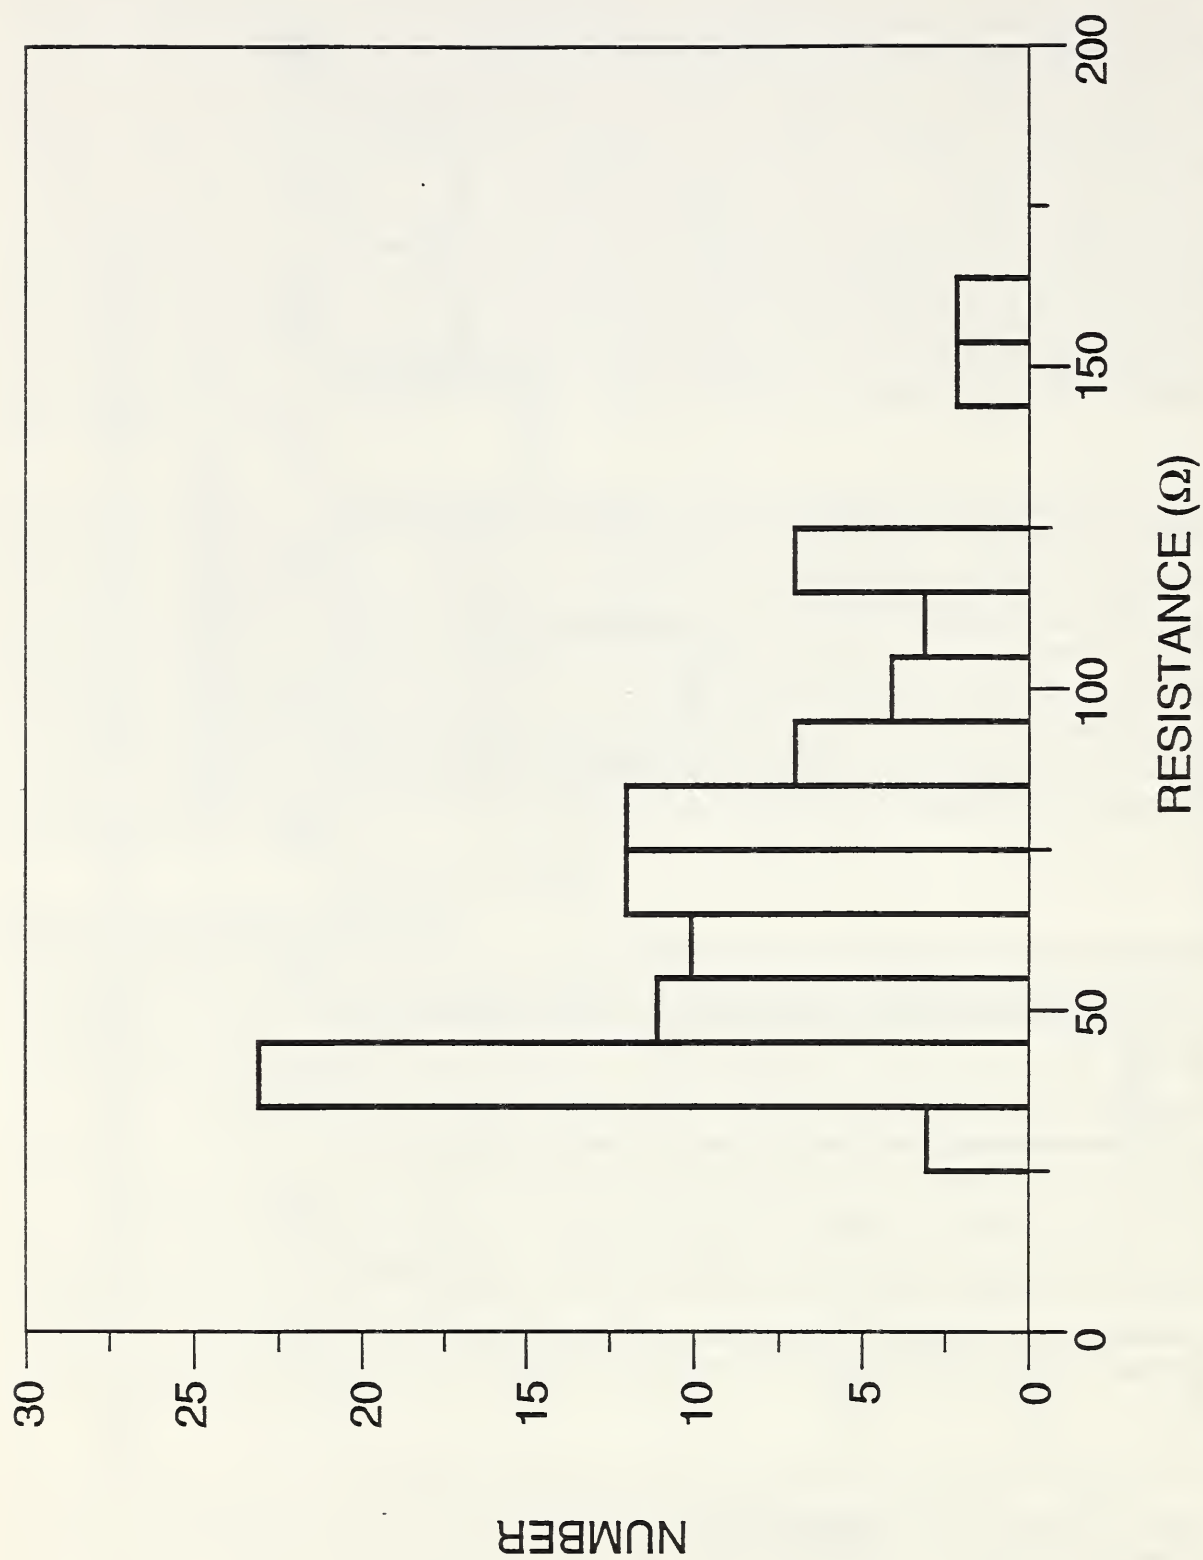
Figure 5.2 Histogram of the resistances of all 11- and 12- μ m detectors available for analysis.

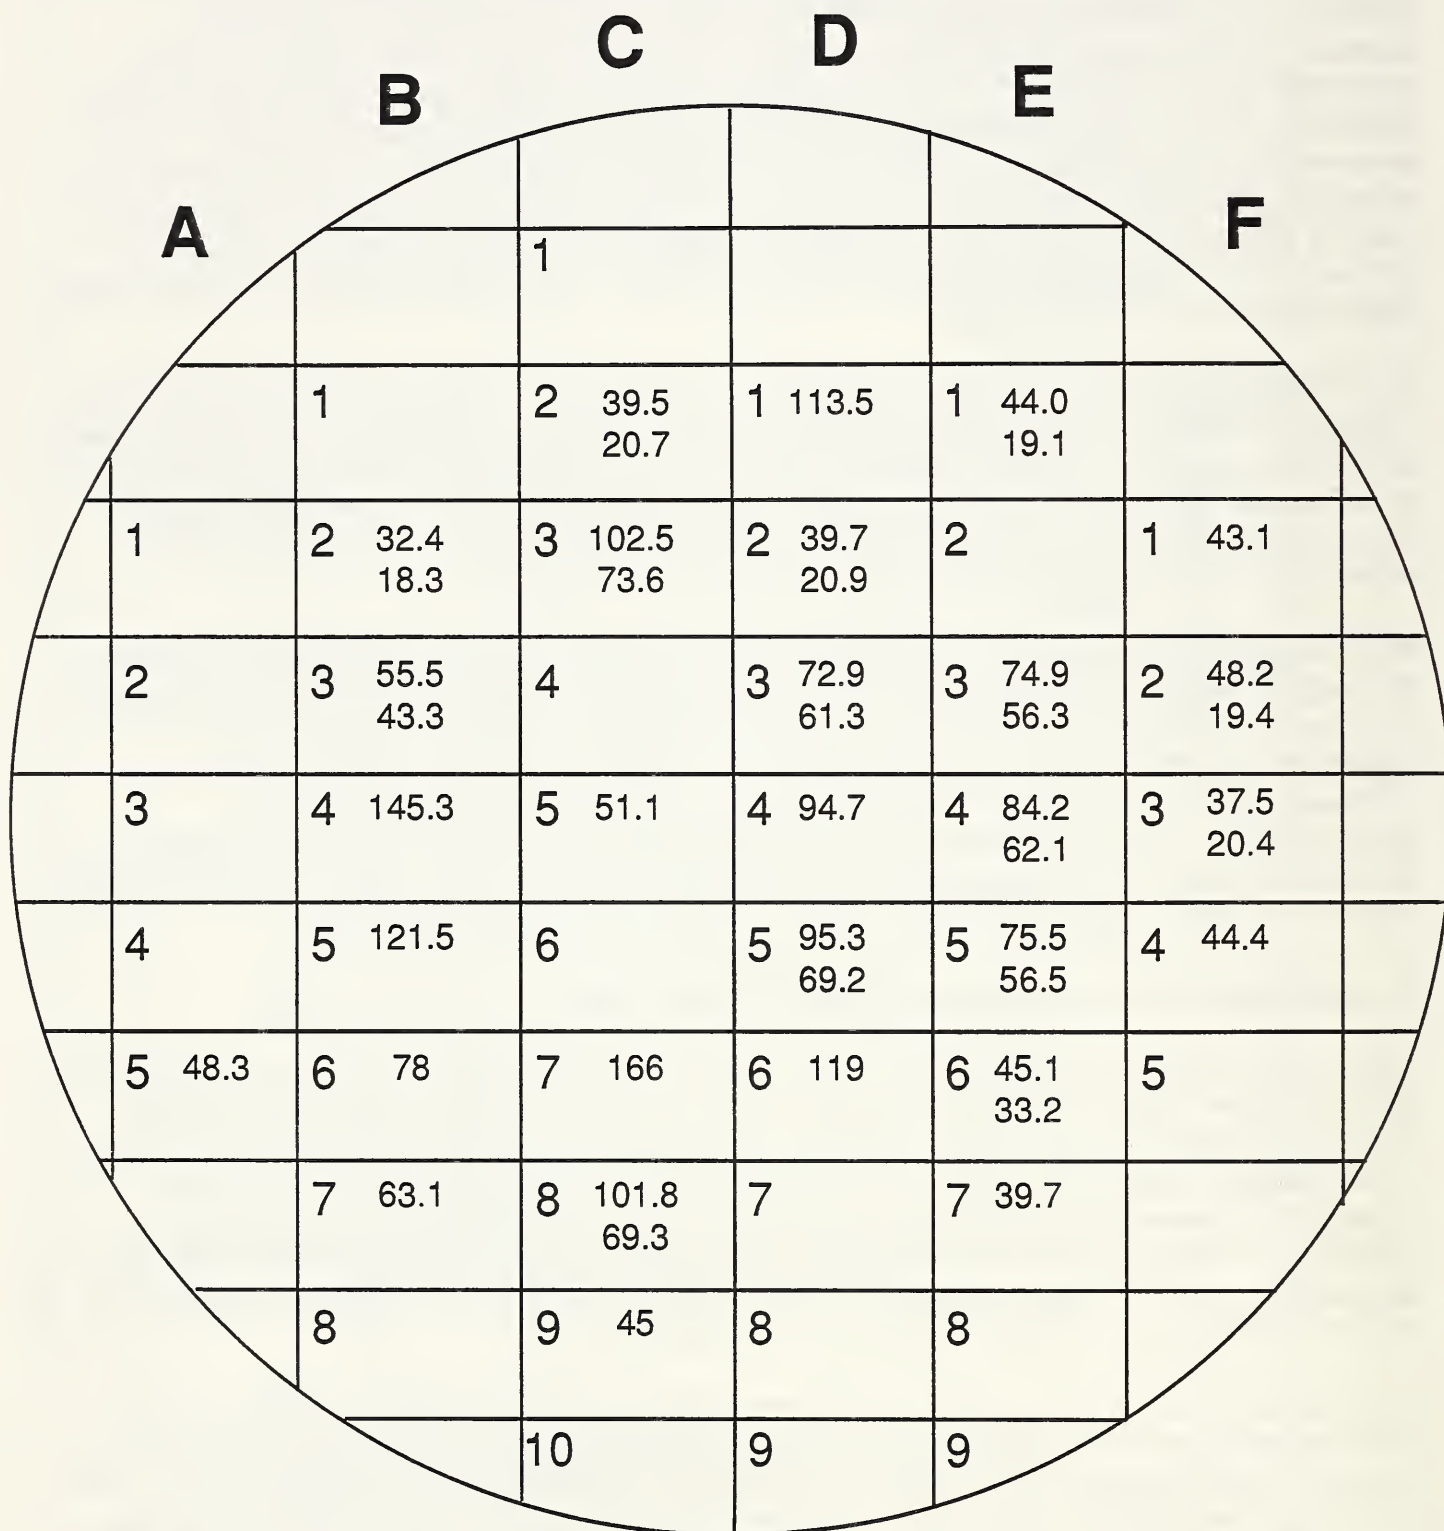
Wafer Map of Detector Resistances (ohms) at T = 105 K and T = 300 K for Wafer P3948-33 (105 K values are top numbers)

Figure 5.3 Wafer map of the 11- and 12- μ m detectors showing the initial 105-K and room-temperature resistance values. Values were not available for all chips identified in figure 4.1.

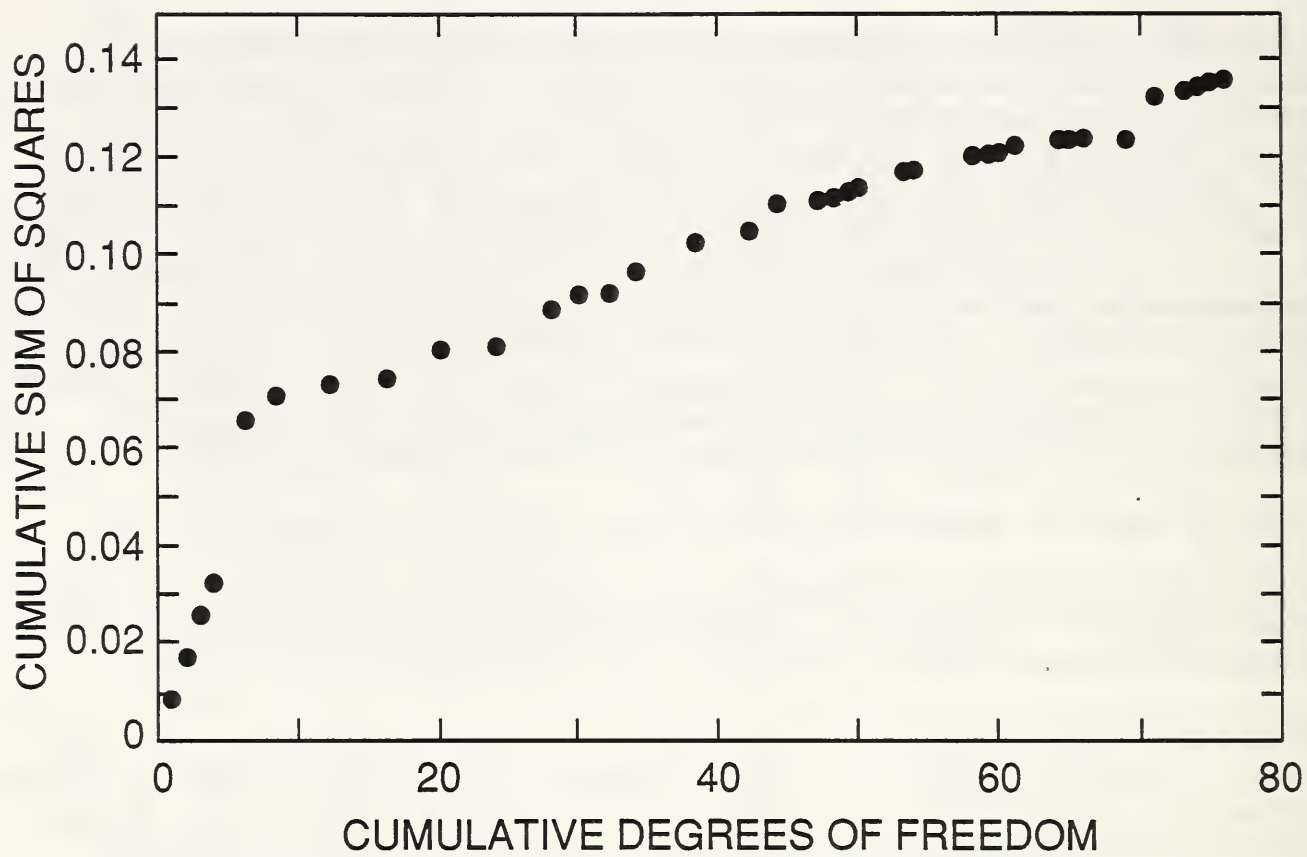
Figure 5.4 Cumulative dependence of the variance on the slope.

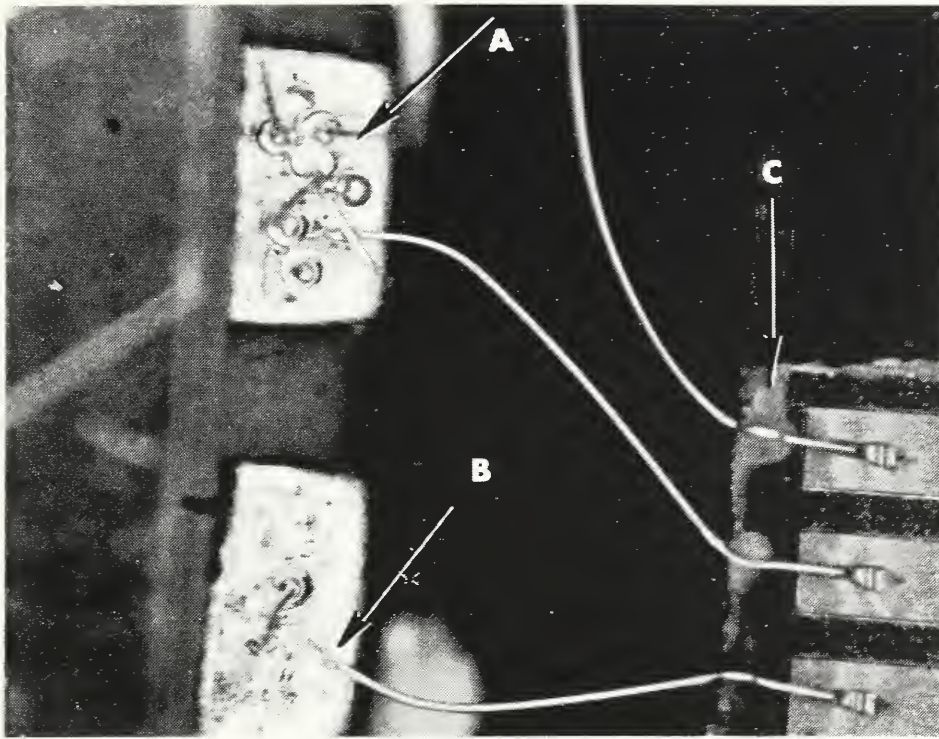
- **Poor wire bonding.** NIST's bonding tests on a number of available detectors found that the range of pull forces and the number of rebonds, both to chip and package, were so large that the bonding operation was out of control and should be considered unreliable.

Figure 6.1 Detector 44792-4: Examples of poor bonding on the package and the silicone rubber staking blobs. (A) shows generally poor and multiple bonds on the package post. (B) shows a poorly placed (too near the edge and poorly deformed) package-to-chip bond. (C) The arrow points to the silicone rubber bond-staking blobs. Both this and figure 6.2 are optical photomicrographs taken at 50X.

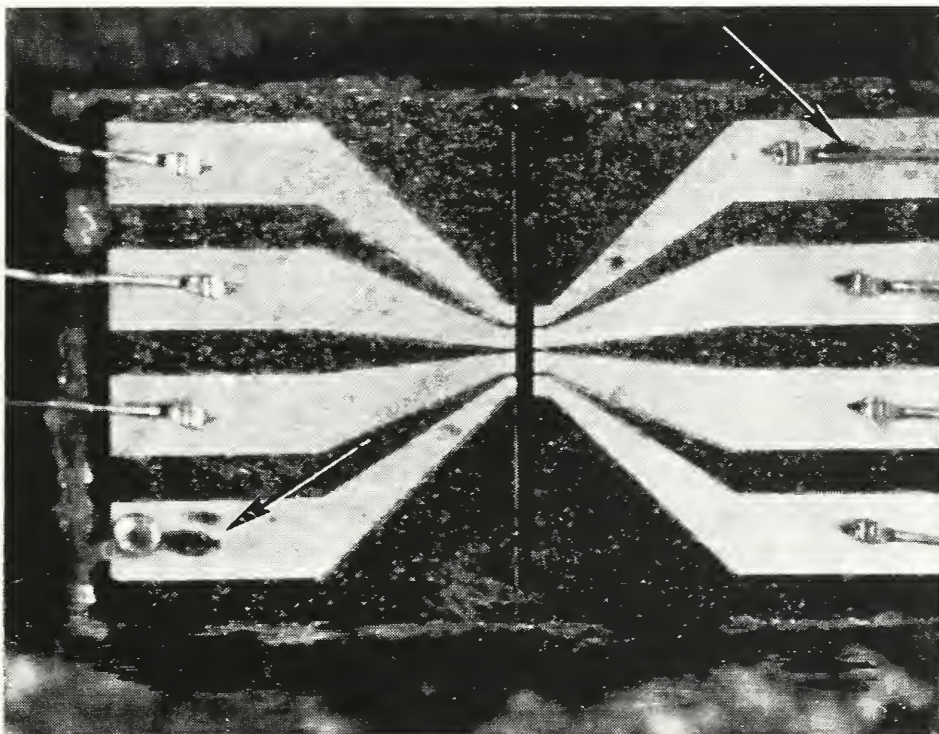
- **Poor indium electrical contacts produced by the indium-plated fabrication step.** The indium-plated electrodes on the detectors are porous and have wormy structures, with individual grains often appearing not to be in contact with neighbors. Optical signals have been observed in the region of indium metallization and high contact resistance has been measured on many of the detectors. These contacts could be unstable over time because of ambient conditions, stresses, and interdiffusions, which can change both the resistance of and signals produced by these regions.
- **Incomplete or poor passivation procedures** which could cause variability of signal and resistance because the surface could be exposed to ambient conditions.

Figure 6.2 Detector 53238-4: Examples of initial nonsticking bonds to the indium. The lift-off is indicated by the arrows (dark patches where the indium was lifted up by the failed bond). Rebonding is apparent nearby. This photograph gives an overview of one of the HgCdTe detector chips. The light colored stripes are indium metallization. These converge onto the HgCdTe detectors in the center.

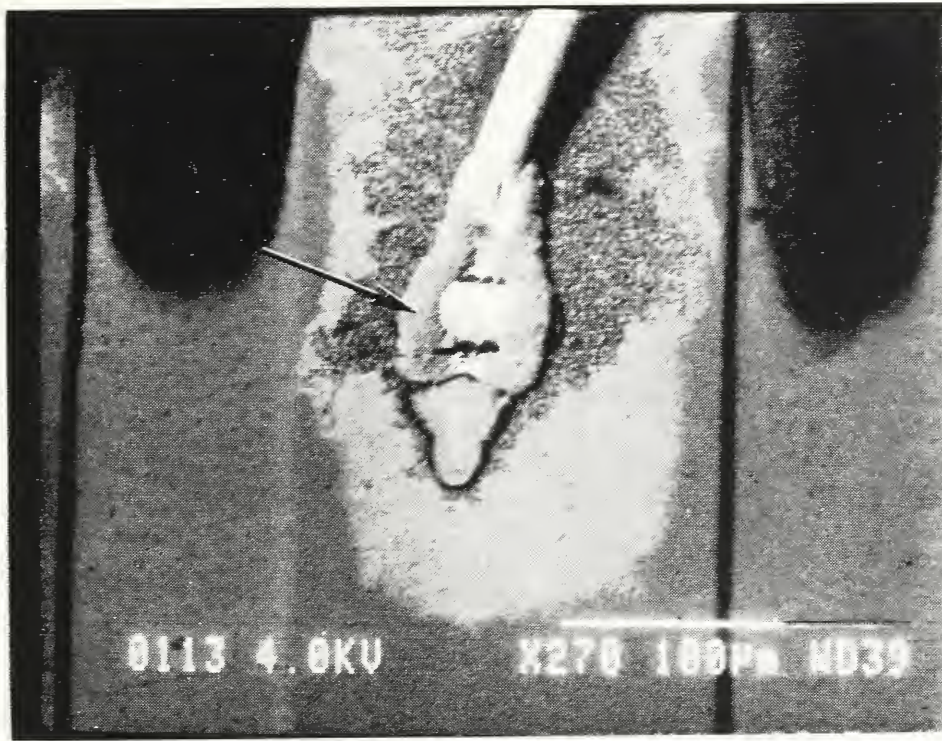
Figure 6.3 Detector 53237-4: This sample is stated to have had 103-h bake at 100 °C. (See above about the nonspecified temperature.) The arrow points to the thick rim of Au-In intermetallic growth around the bond. The darkened area on the indium metallization results from indium depletion as the indium diffused into the gold bond. This and figure 6.4 are SEM photographs with scale indicated by white markers.

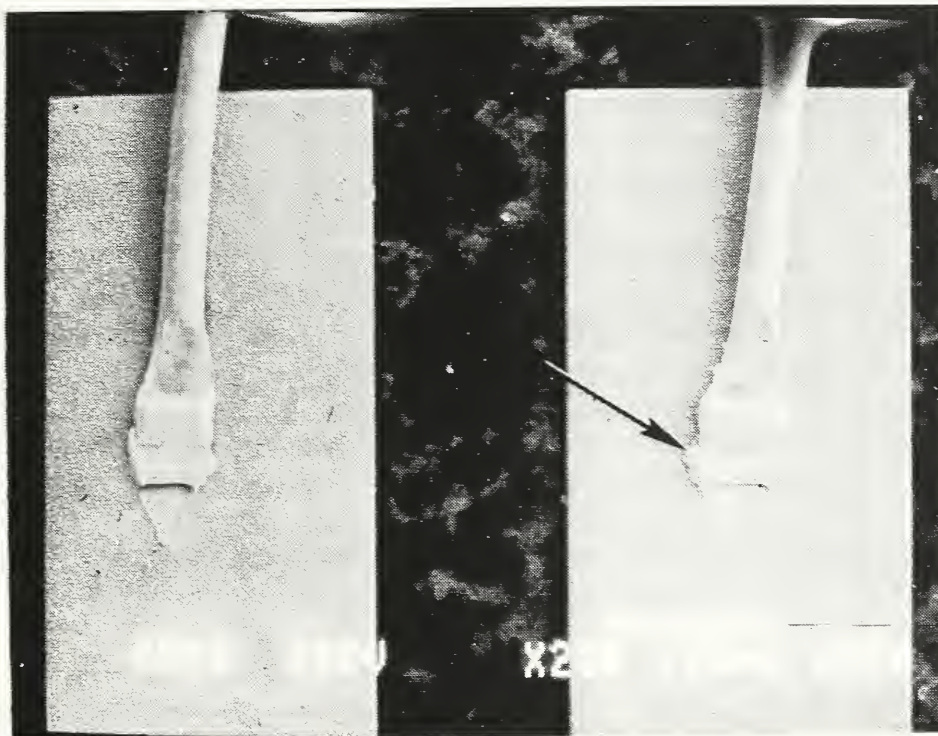
Figure 6.4 Detector 45839-4: This sample is reported to have seen the same thermal bake as in figure 6.3. Two gold wire bonds are shown on indium metallization stripes. Only a minor amount of intermetallic compound is seen, and the largest part of it is indicated by the arrow. Note: all other samples (except fig. 6.3) revealed less intermetallic formation than this sample.

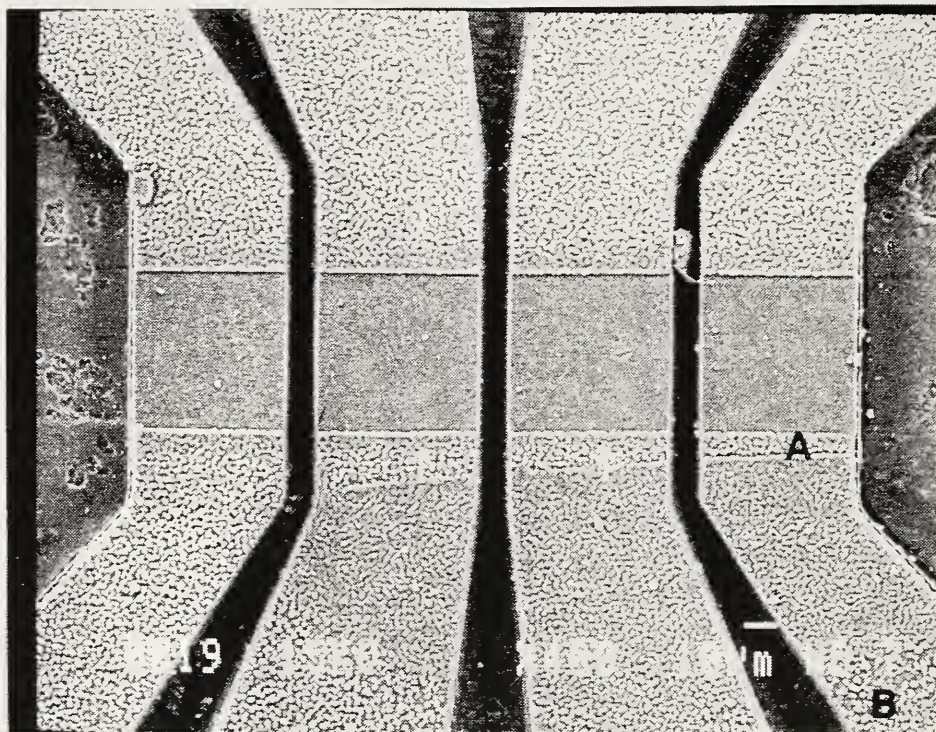
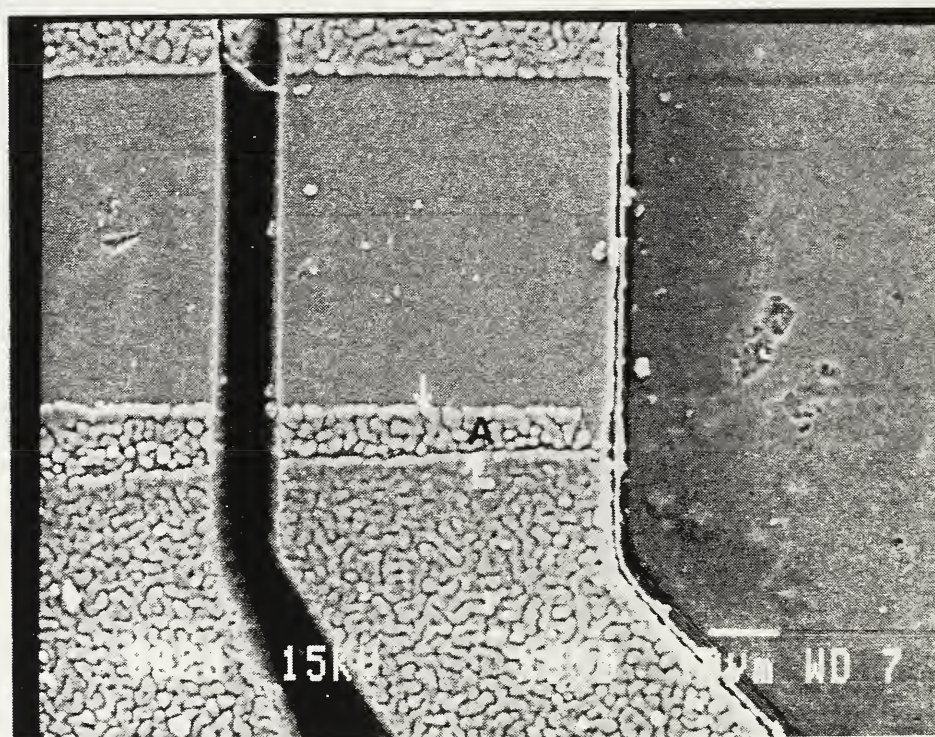
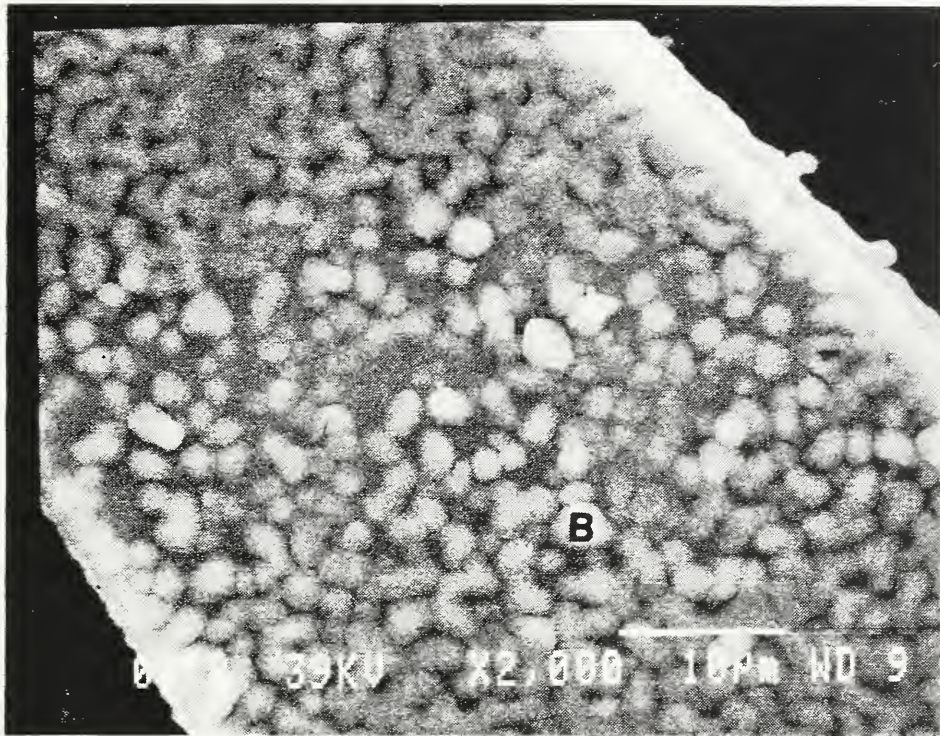
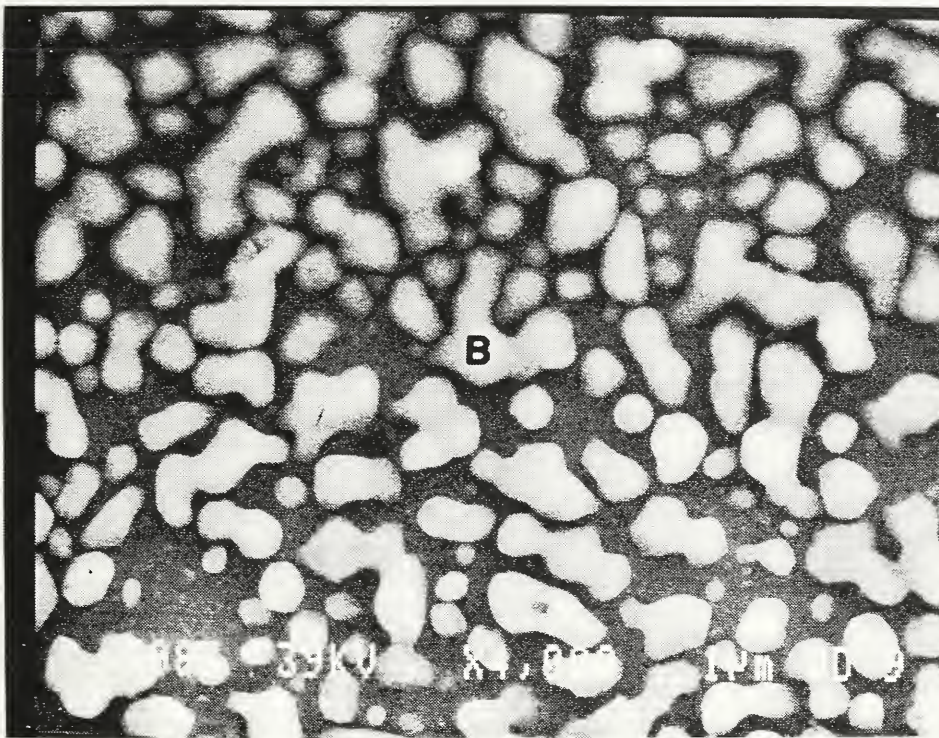
The area under the wire bond is assumed to be a mechanically strong, electrically stable contact to the HgCdTe (as discussed above). When the indium film offers a sufficiently high horizontal resistance, then some of the bias field will appear in a shunt path in the underlying HgCdTe film. The field will no longer be shorted out from the wire bond to the detector area by the indium. Any light that falls in the voids between indium grains will generate carriers that will be swept out by the fringing field and thus be detected. Without such electric fields in the underlying HgCdTe, there could be no photosignals originating from the indium "covered" contact region. Thus, such optical sensitivity is a direct test of both the porosity and the resistivity of the film. One might speculate that a high-resistivity film would result in a high $1/f$ noise, but this has not been proven.

Figure 6.5 An overview of the metallization in Detector 12-111. (A) is an unusual indium plating that shows some separation from one part of the indium film to the main part. (B) is an area with large spacing between indium grains where horizontal electrical conductivity could not occur. Figures 6.5c and 6.5d are closeups of this area.

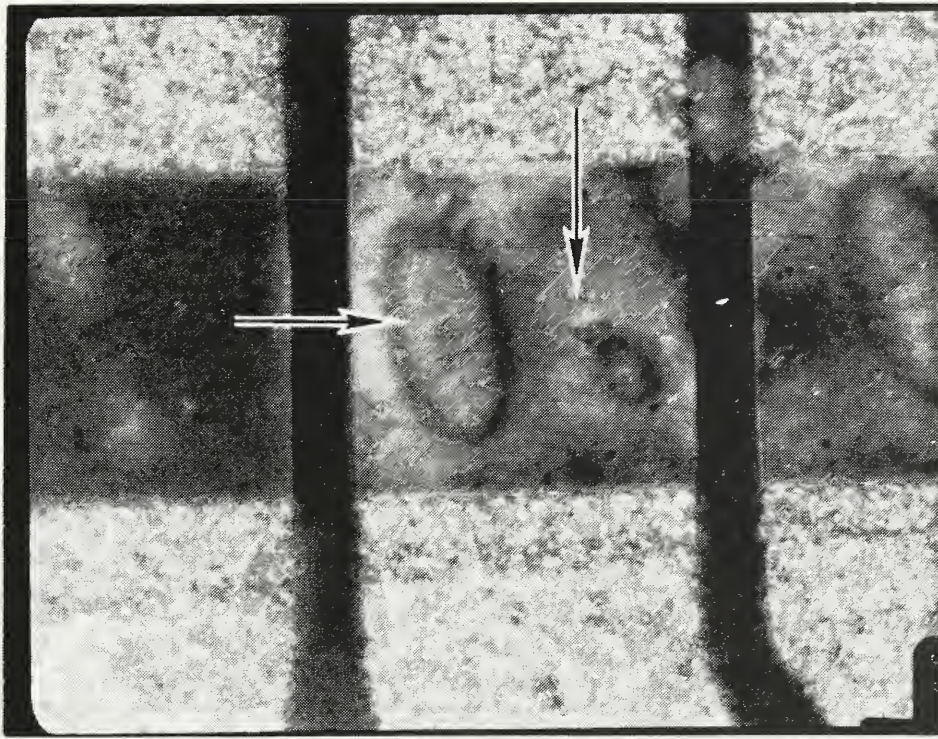
Figure 6.6 Apparent separation of the ZnS and/or passivation film on Detector 12-111. Three out of four elements showed major separation. The horizontal arrow points to one of the "bulges," as revealed by Nomarski microscopy. The vertical arrow reveals one of the large pits in the surface of the HgCdTe.

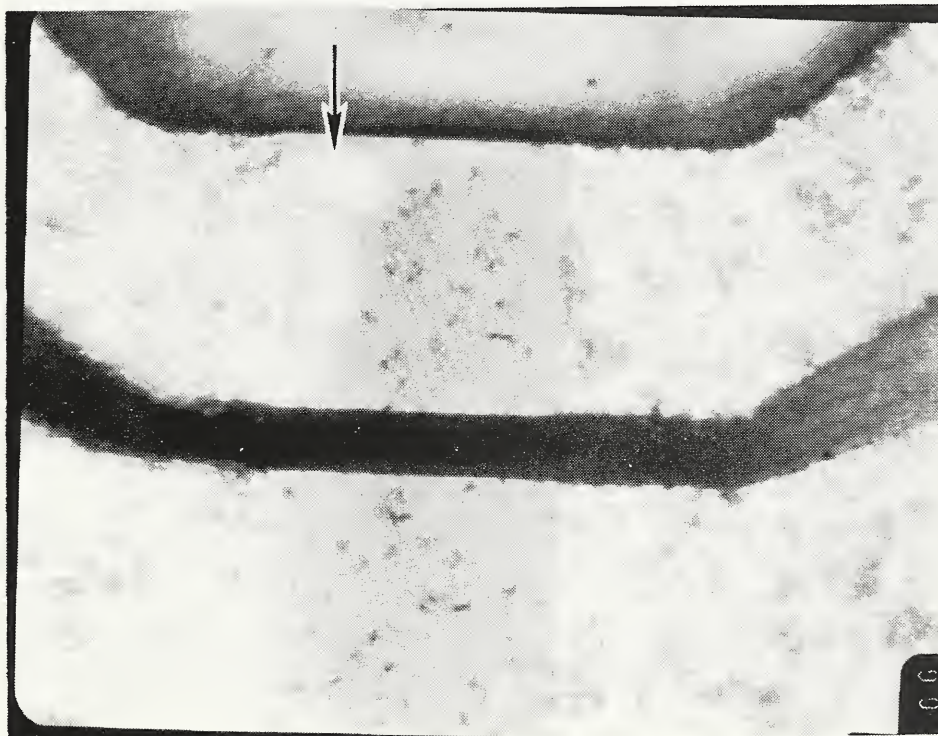
Figure 6.7 Two elements of Detector 45839-4 are shown with the arrow pointing to several separation "bubbles" or "bulges."

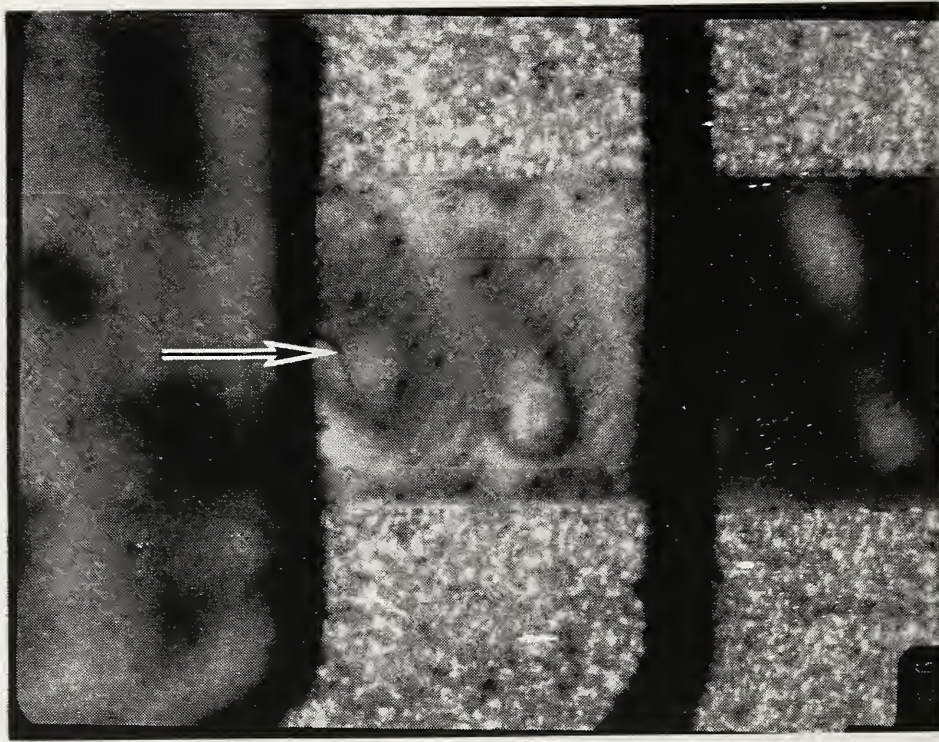
Figure 6.8 The arrow points to a crack in the ZnS optical coating on Detector 12-111. Several separation bubbles or bulges are evident. This is the same detector as in figure 6.6 but the photograph is of elements to the left of it.

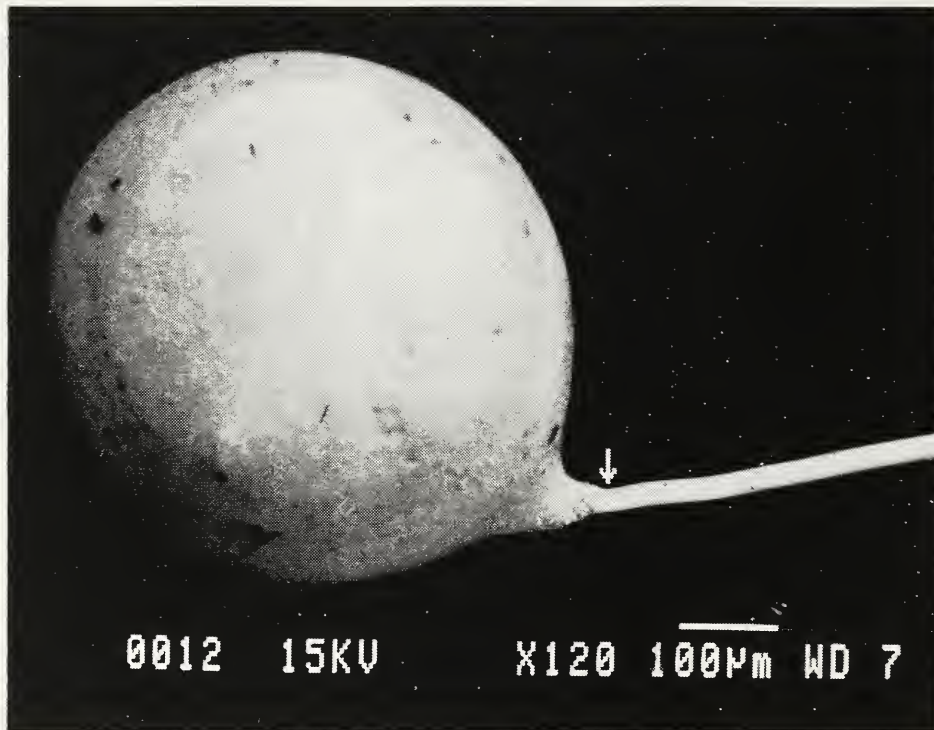
- **Use of tin-lead solder to couple the fine gold wire (bonded to the detector) to the package terminal.** Solder reacts rapidly with gold, dissolving it and/or converting it into a brittle intermetallic compound which could crack during temperature cycling. Tin-lead soldering is avoided in the microelectronics industry.

Figure 6.9 A top view of one electrical lead-through in Detector 12-111. The round shape is a high tin content soft solder. The 25- μ m-diameter gold interconnection wire (from a detector element) is shown going off to the right. An arrow points to the interface of the gold wire and the solder, and the next two figures show closeups of that area.
